2007 RRFM/IGORR

JRR-3 MAINTENANCE PROGRAM UTILIZING ACCUMURATED OPERATION DATA

**JRR-3 Operation Division
Department of Research Reactor and Tandem Accelerator
Japan Atomic Energy Agency**

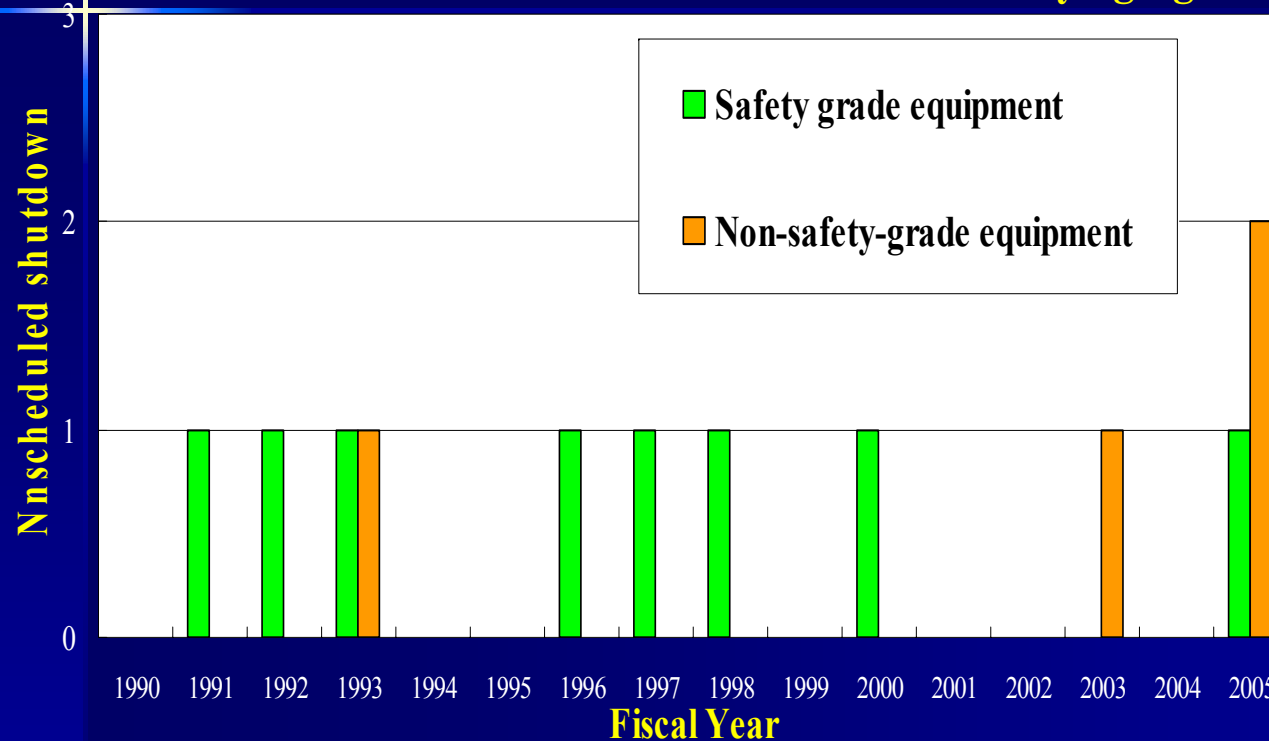
Number of unscheduled shutdown caused by aging

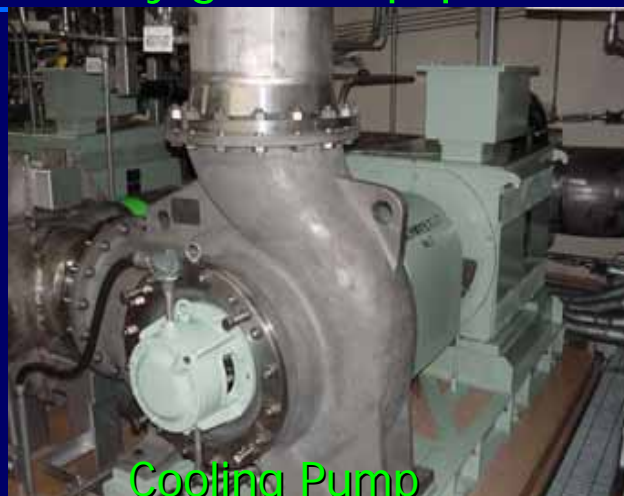
Cooling Pump

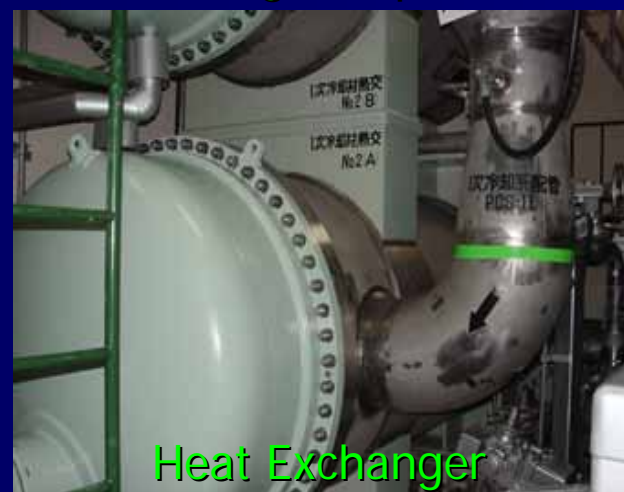
Heat Exchanger

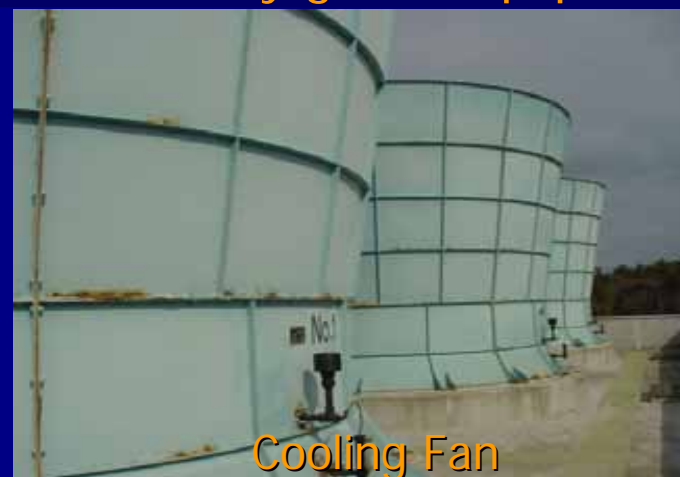
Cooling Fan

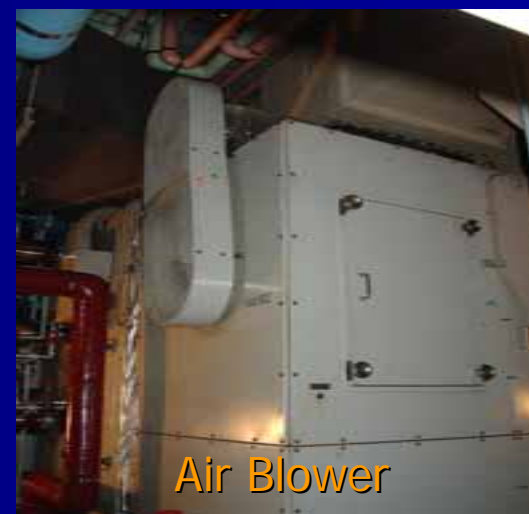
Air Blower

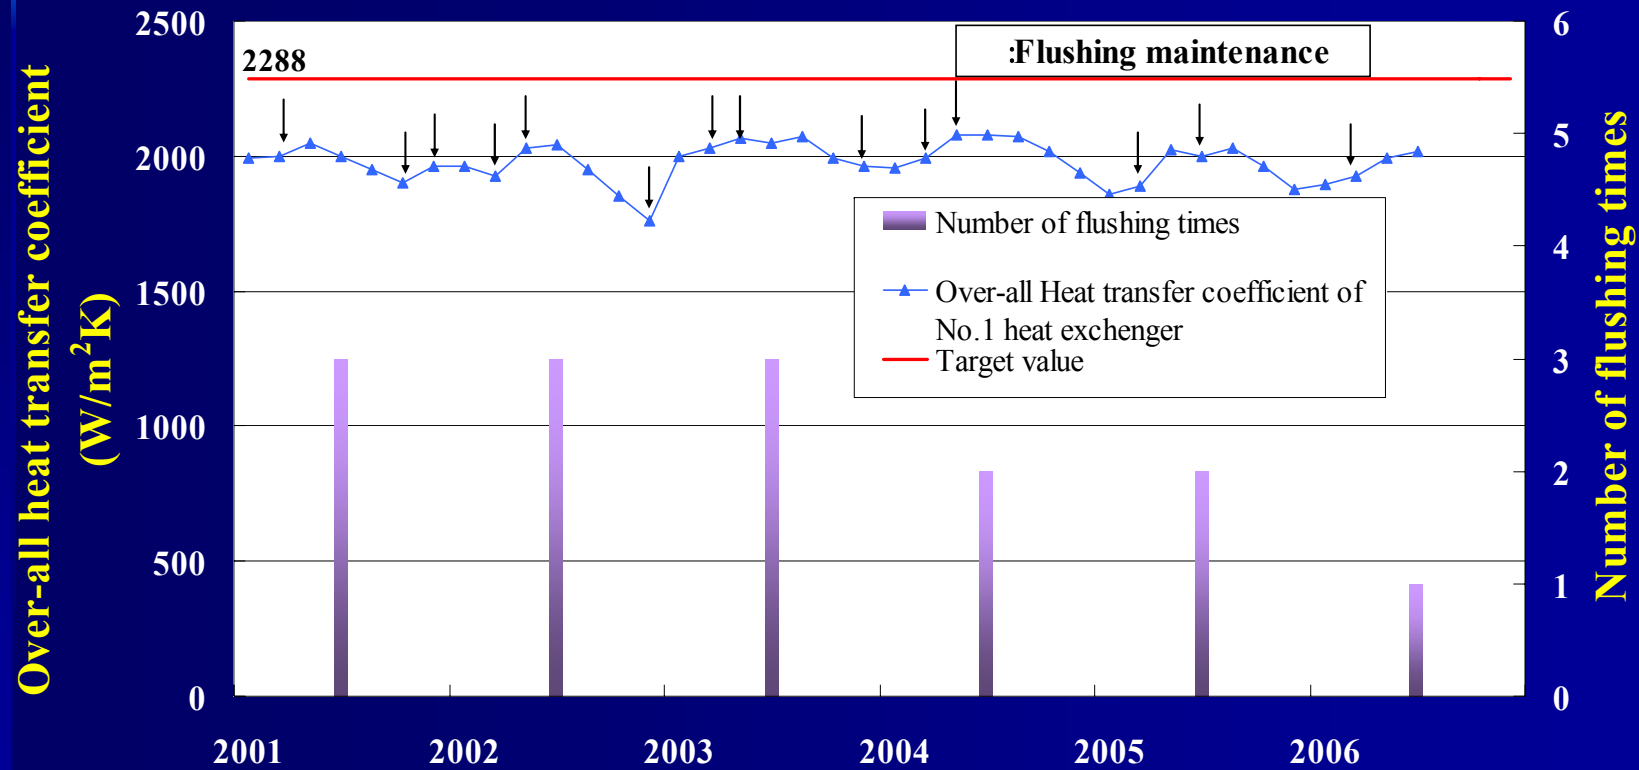
Relation between flushing maintenance and Over-all Heat Transfer Coefficient

Evaluation Item		Result	Notes
Shift to C.B.M.		<u>Shift</u>	Possibility of excessive maintenance
P.I.	Observe item and interval	<u>Over-all Heat Transfer Coefficient / Cycle</u>	-
	Criteria	<u>1900W/m² · K</u>	Maintenance will be planned in next cycle

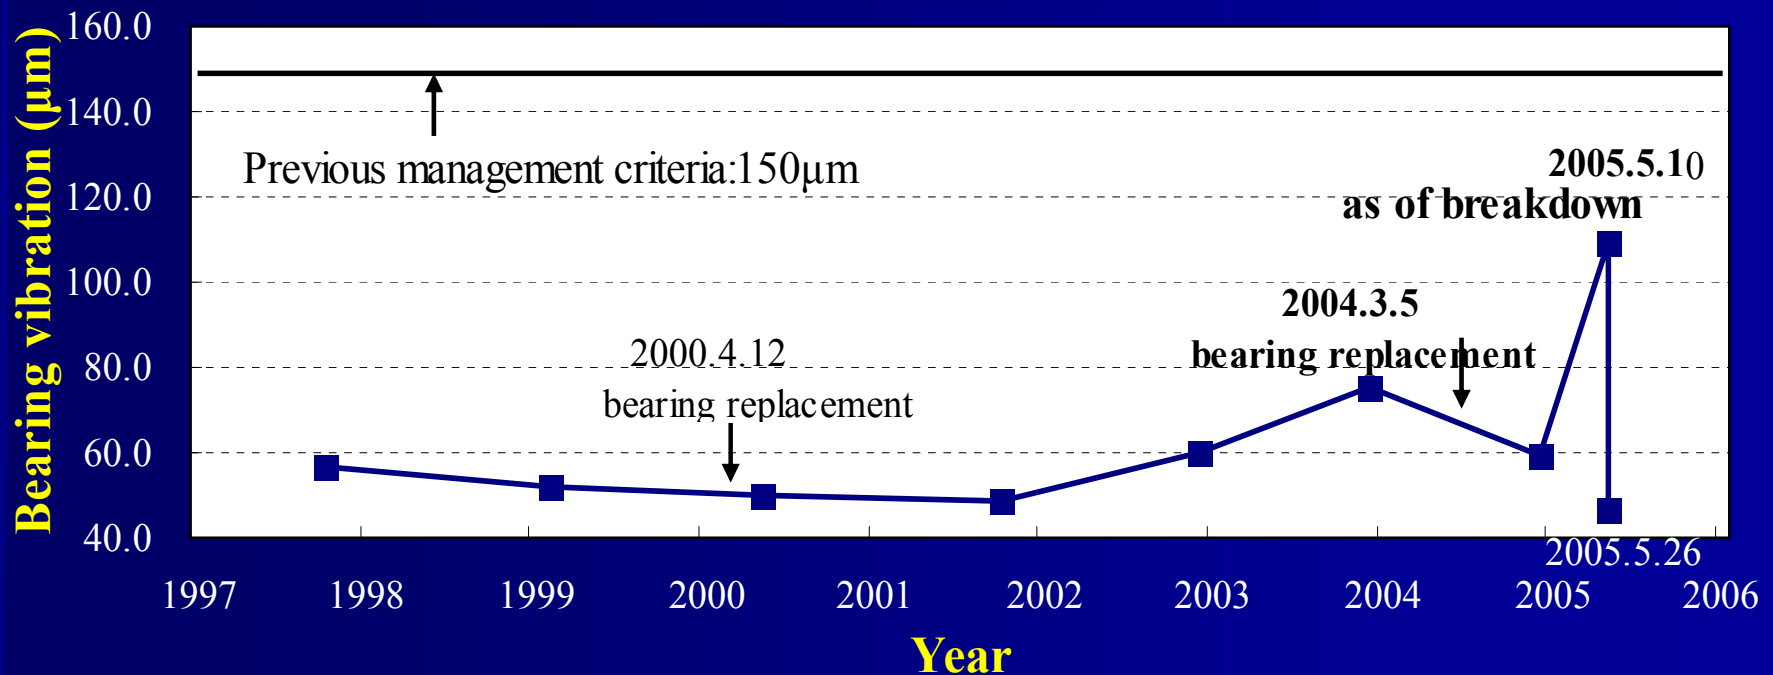
Vibration data of air blower

Evaluation Item		Result	Notes
P.I.	Observe item and interval	<u>Vibration measurement and the sound detection inspection / once per half a year</u>	-
	Criteria	<u>60 μ m</u>	The overhaul which includes both the bearing replacement and the shaft size-measurement would be planned
