VIBRATION MONITORING AND DIAGNOSIS AT THE IEA-R1 NUCLEAR RESEARCH REACTOR

Research Reactor Center and Nuclear Engineering
Center of Instituto de Pesquisas Energéticas e
Nucleares

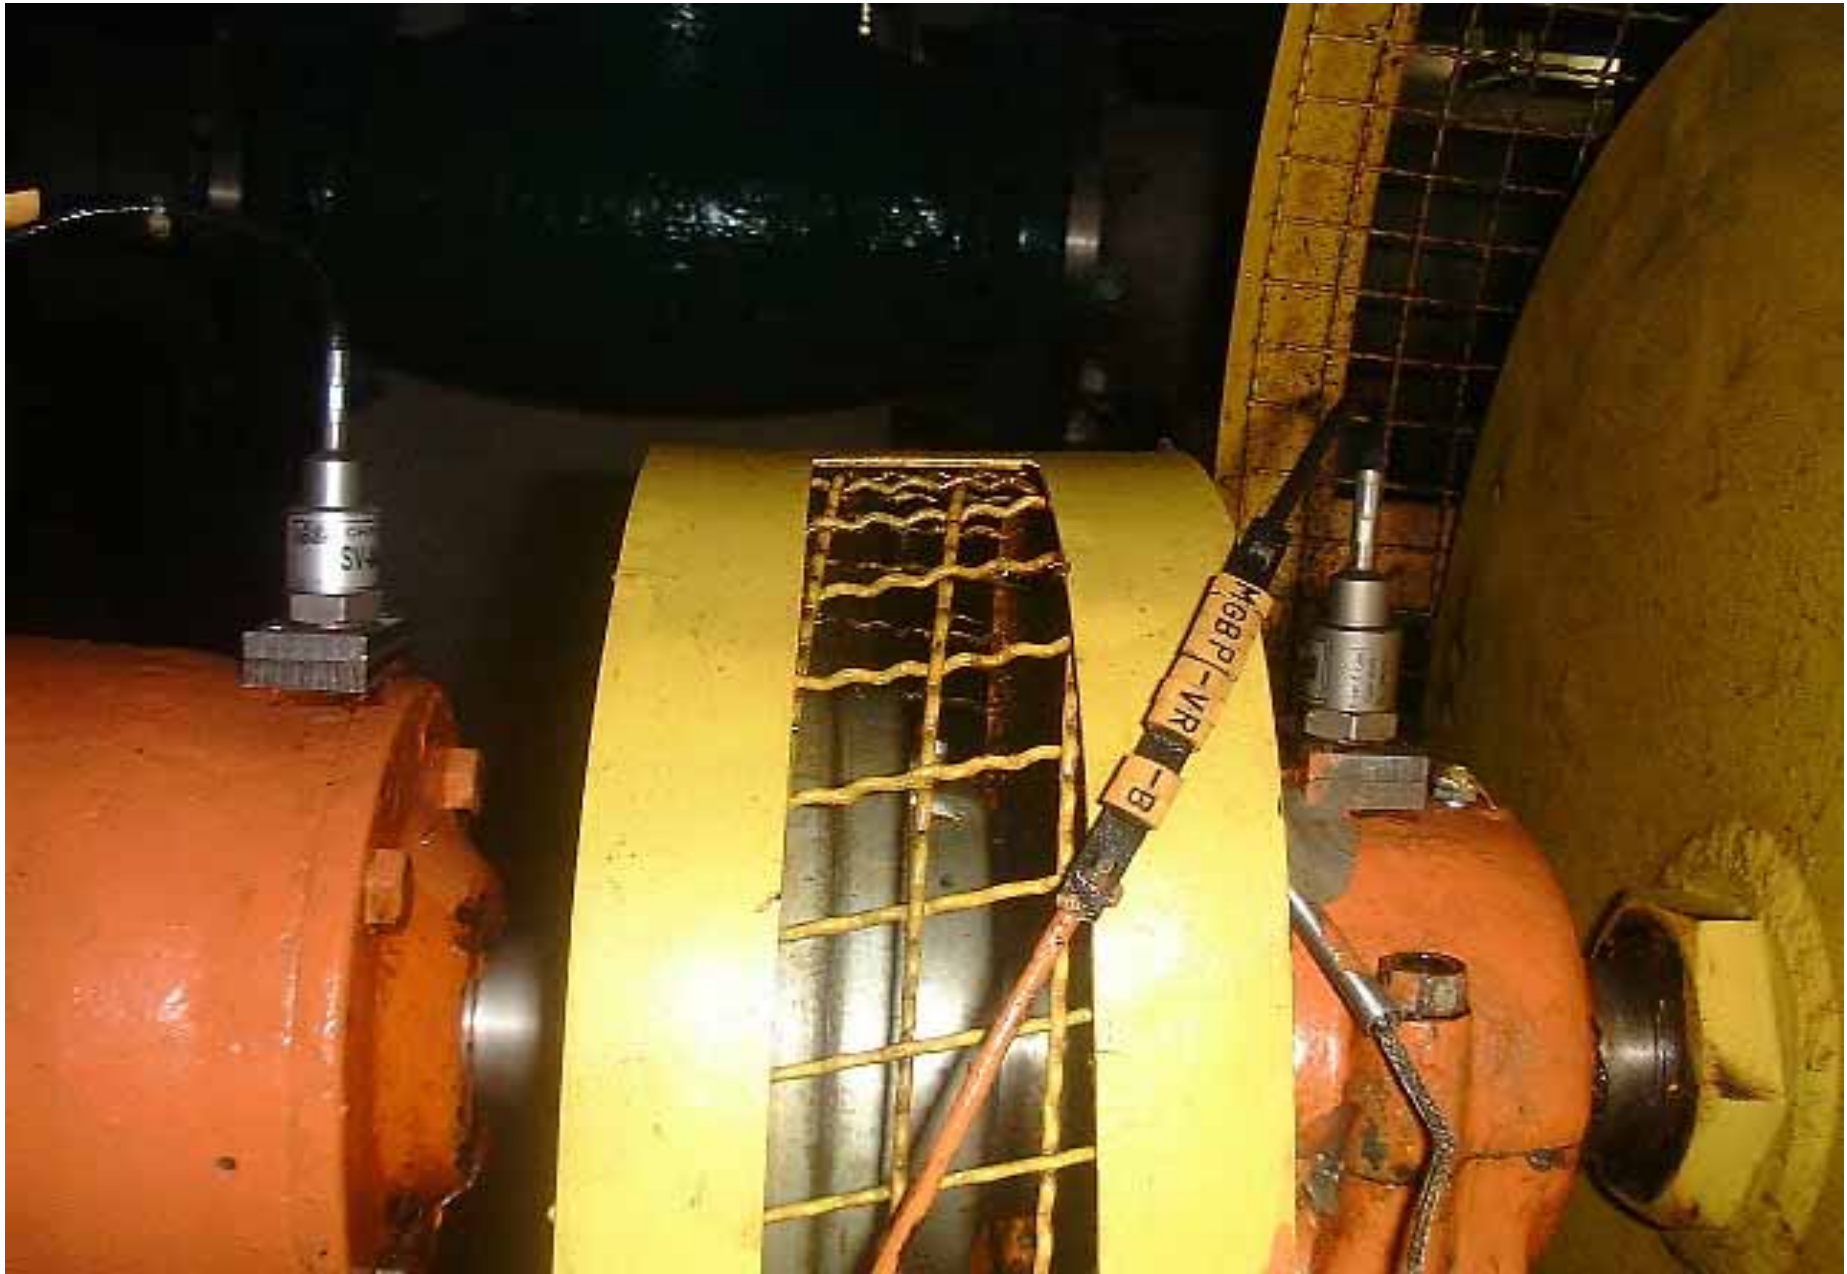
Bearings and accelerometers of the B Pump

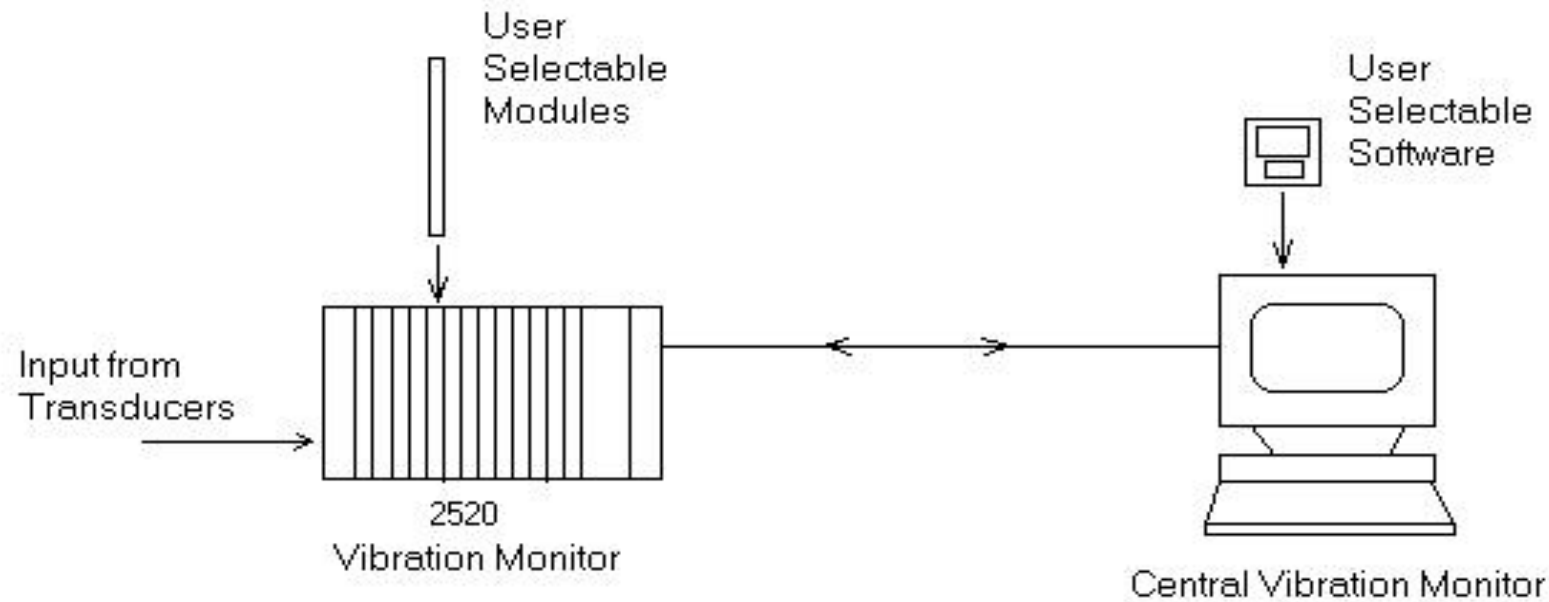
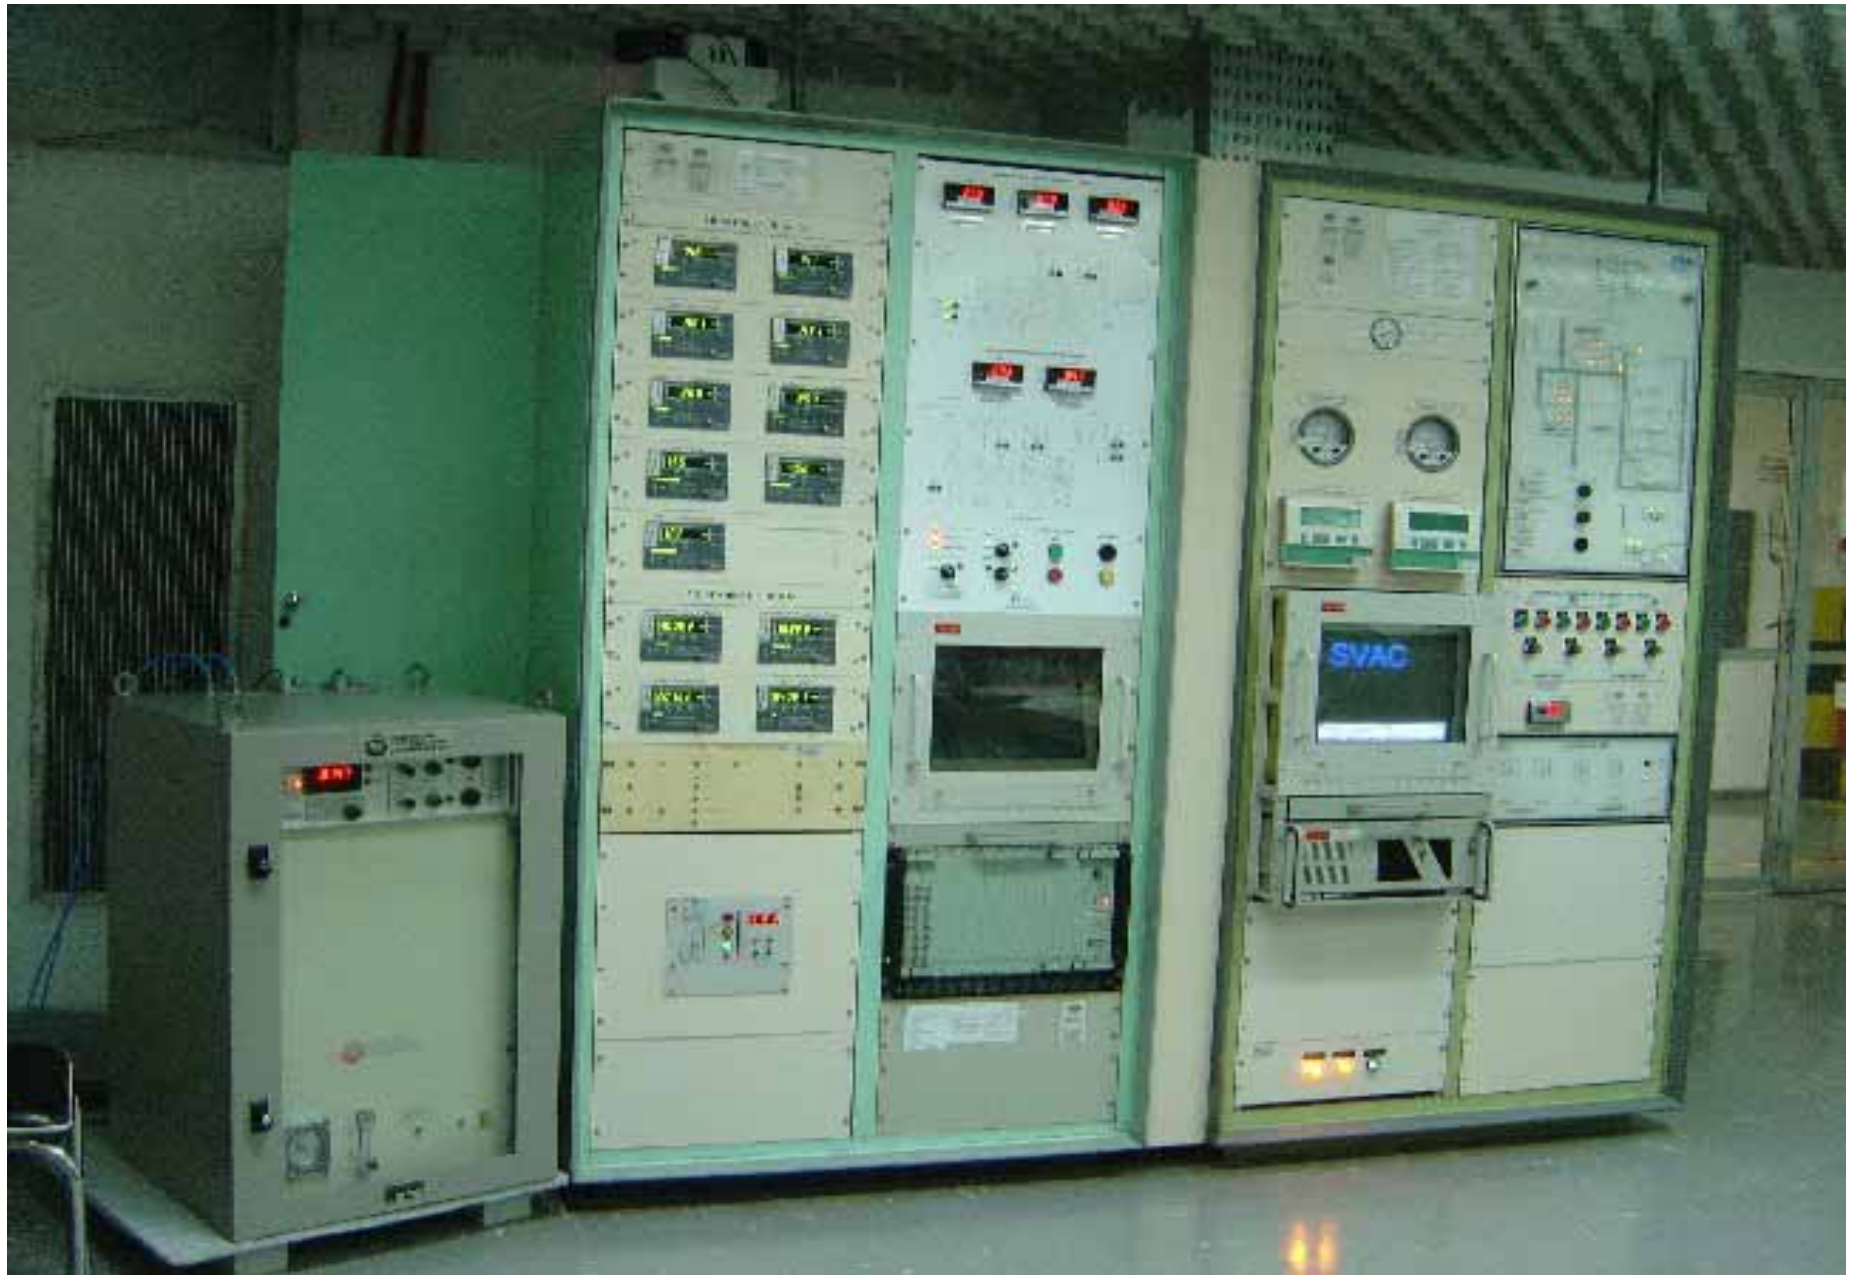
Some panels at the Control Room

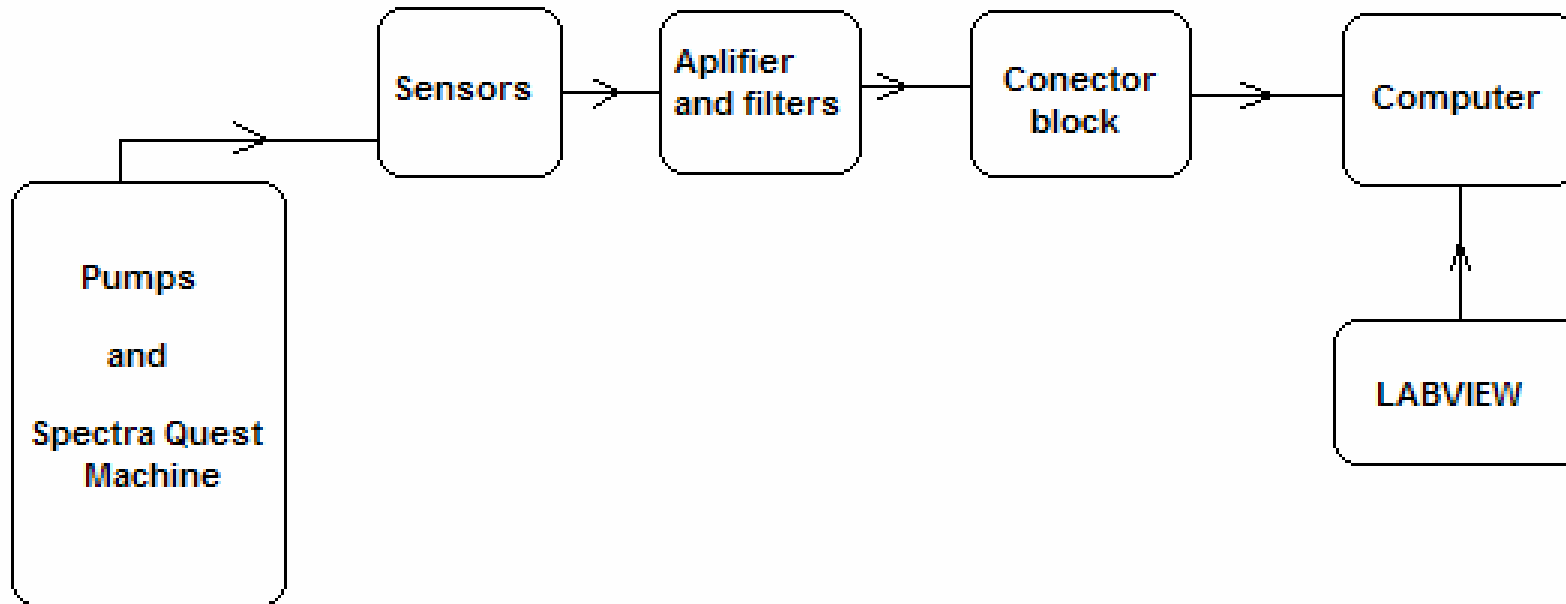
The parallel signal acquisition equipment

- research
- complementar monitoring

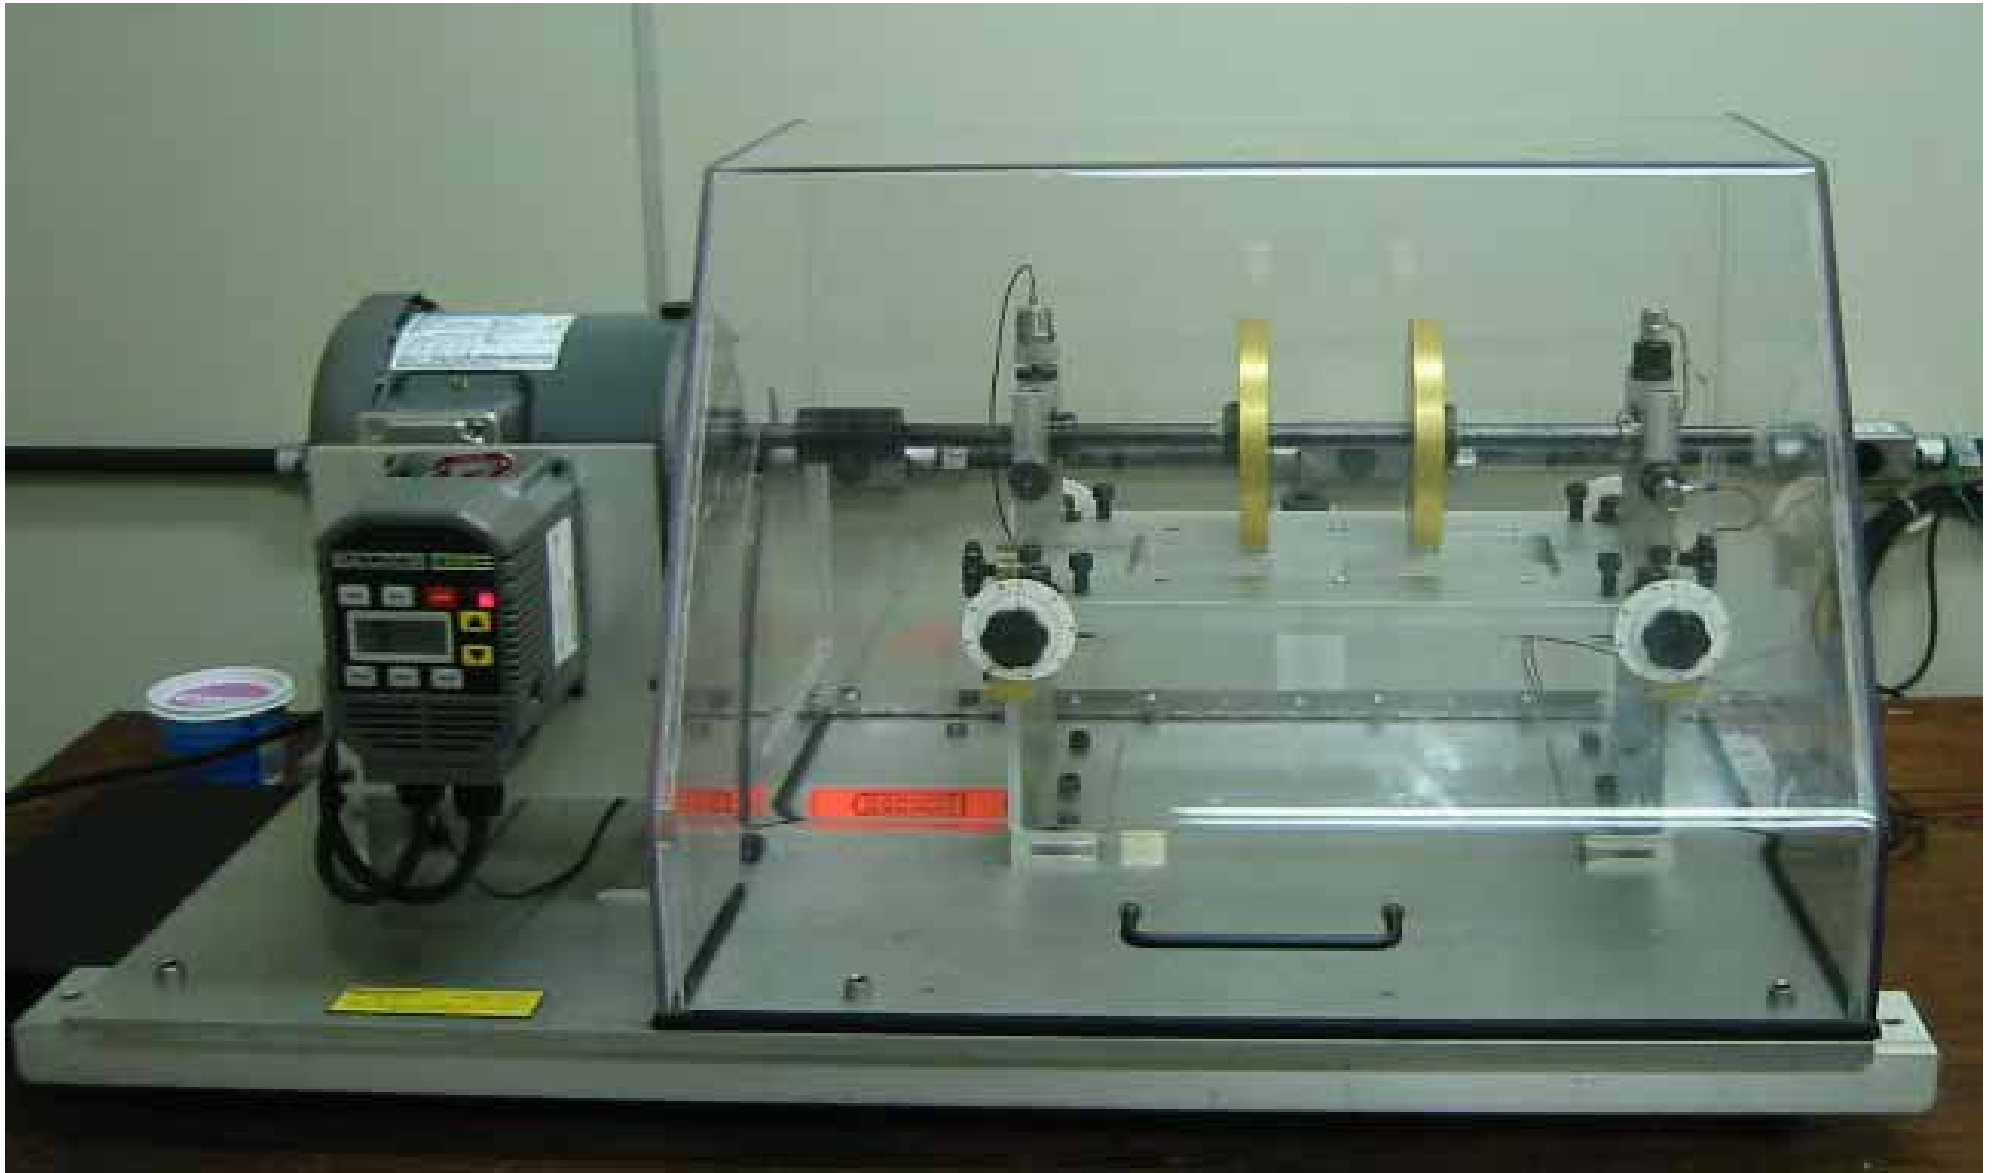
The MDSM (Spectra Quest)

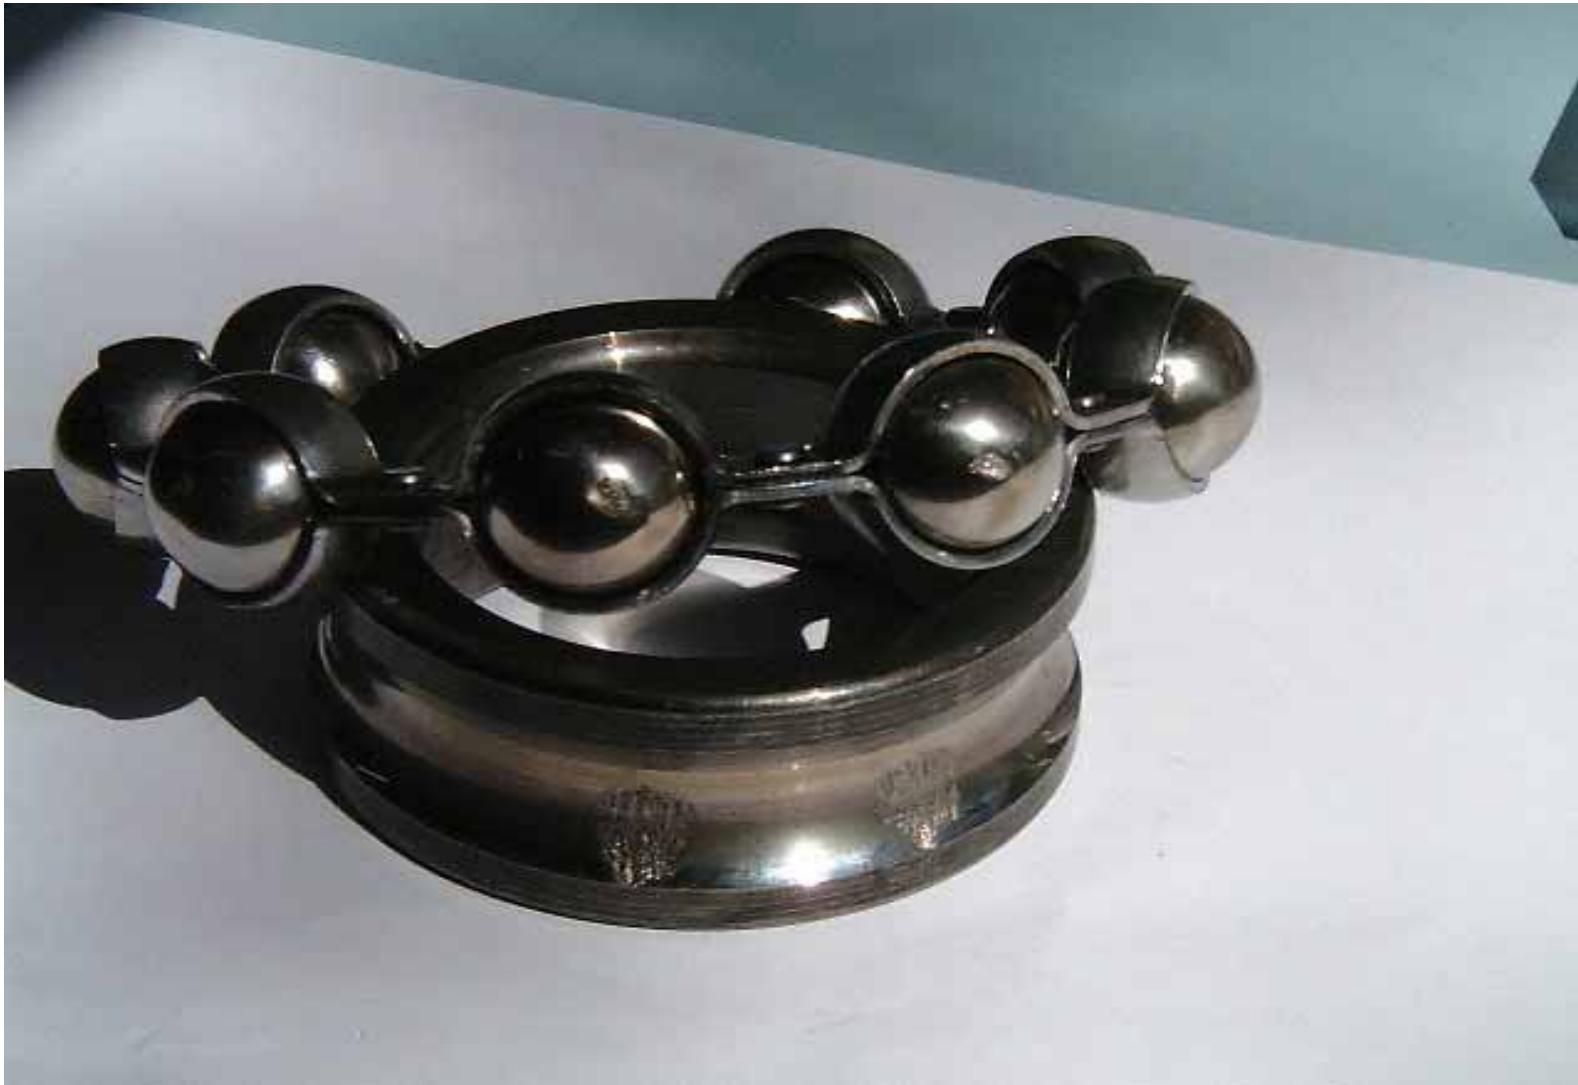
rolling bearing of the pump oil box

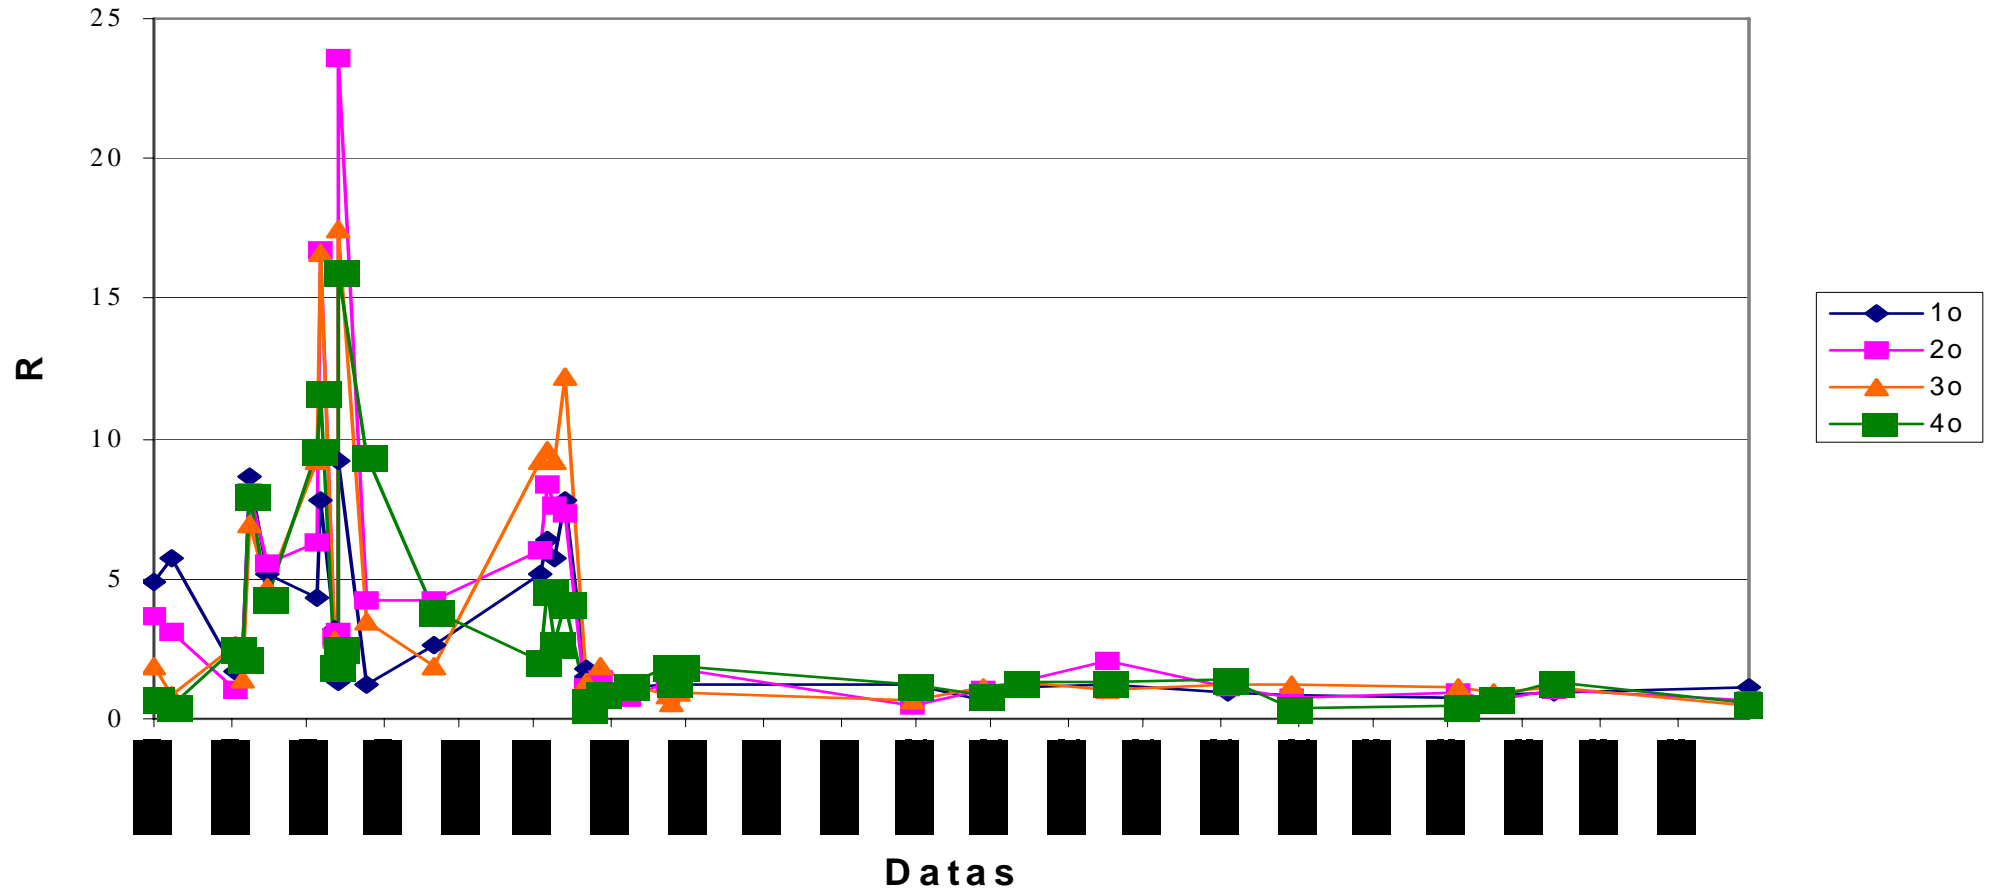
Lubrication problem in the A Pump until May 2001

shaft speed harmonics at A3 position

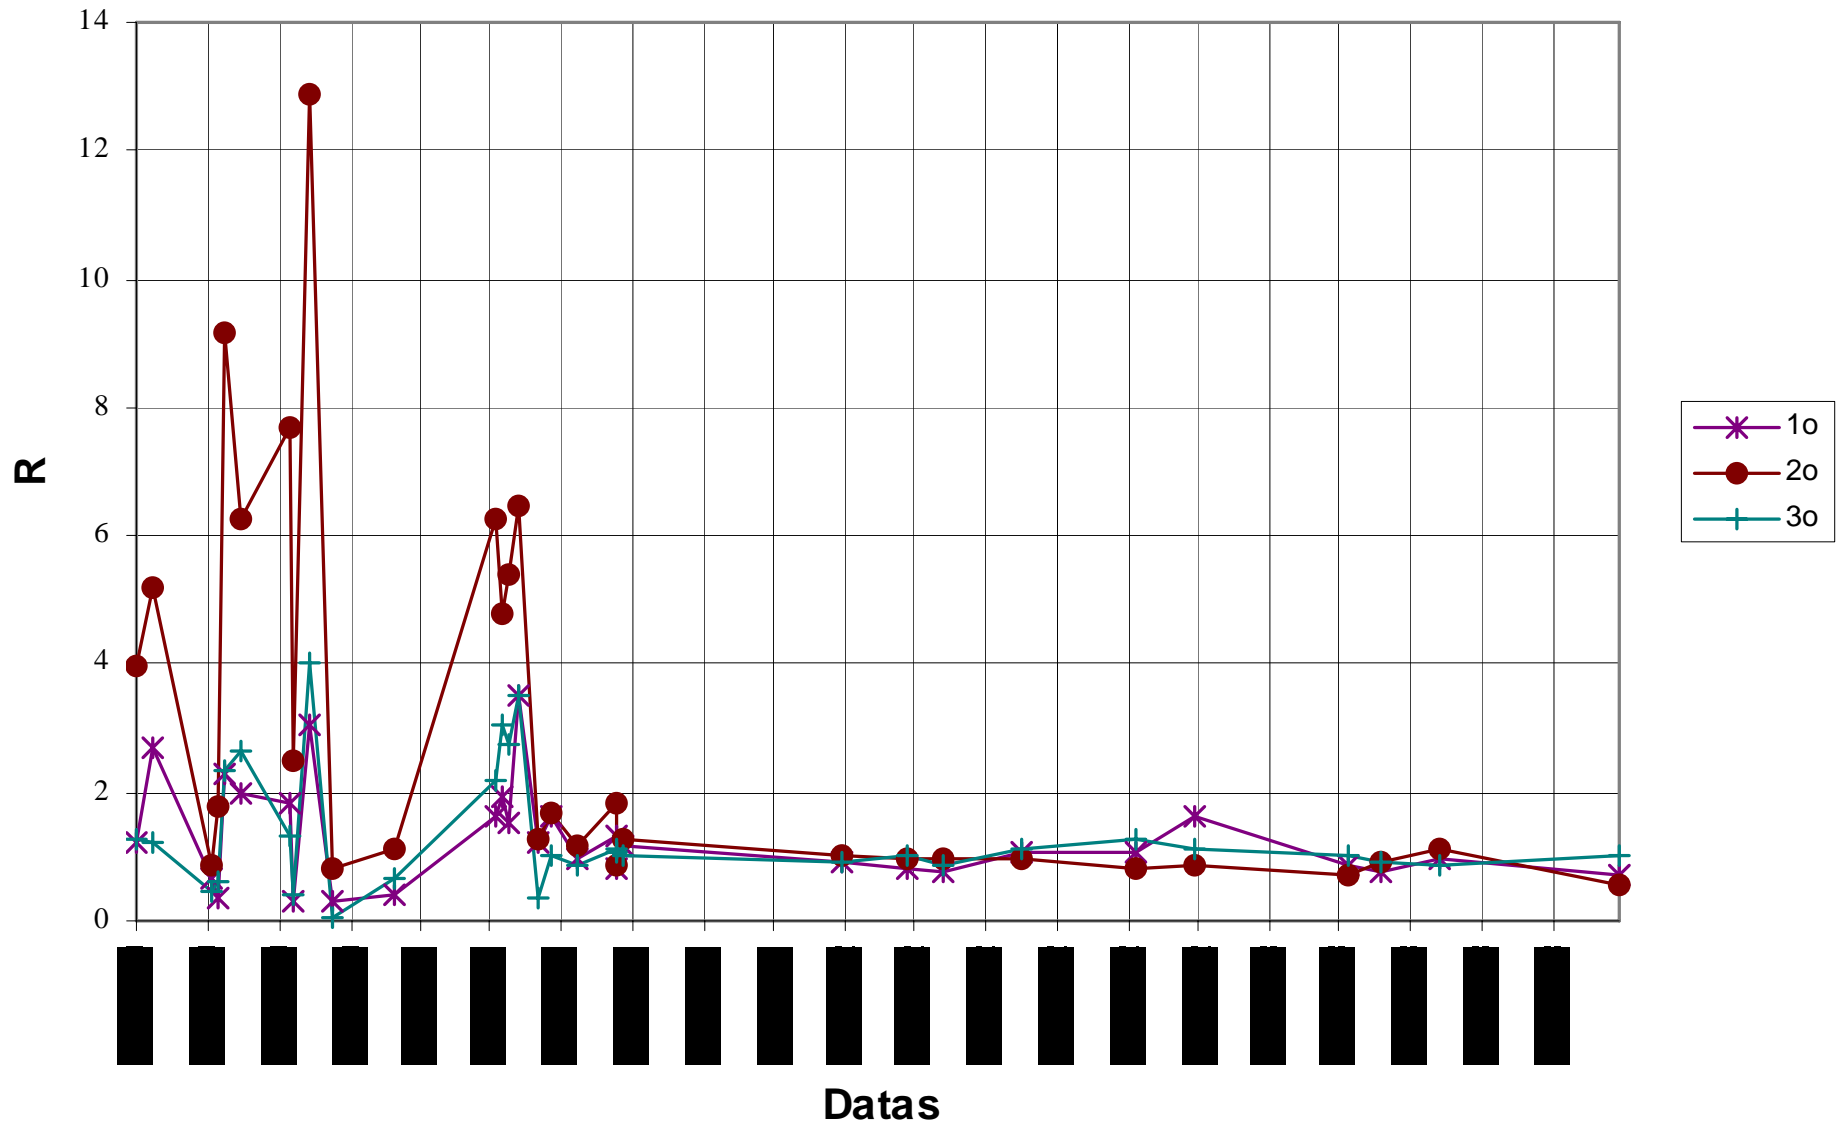
harmonics of the outer race defect frequency in the velocity spectrum (f_{o_v}) at A3 position
